Report No. COESAM/PD-EC-84-004

OF SUBMERGED ANOMALIES, MOBILE HARBOR, ALABAMA

Prepared for:
U.S. Army Corps of Engineers, Mobile District

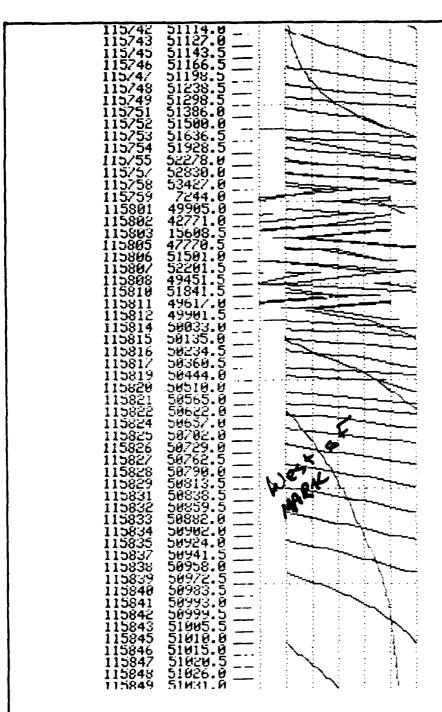
Figure 7
MAGNETOMETER CHART ANOMALY TB-2-2
Vessel Direction East to West
Estimated Vessel Speed 2.5-3 Kts, Sample Rate I.O sec.

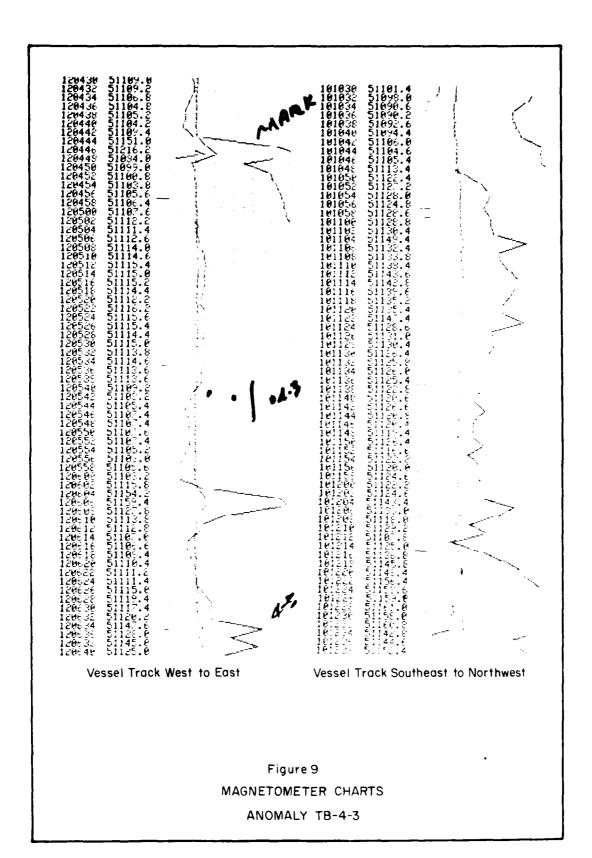
30 gammas) with multiple peaks sometimes exceeding 100 gammas scattered throughout the area (Fig. 9). A buoy was dropped on a 110 gamma strike which was located 15 ft (4.6 m) northwest of the buoy marking the recorded UTM position for this site.

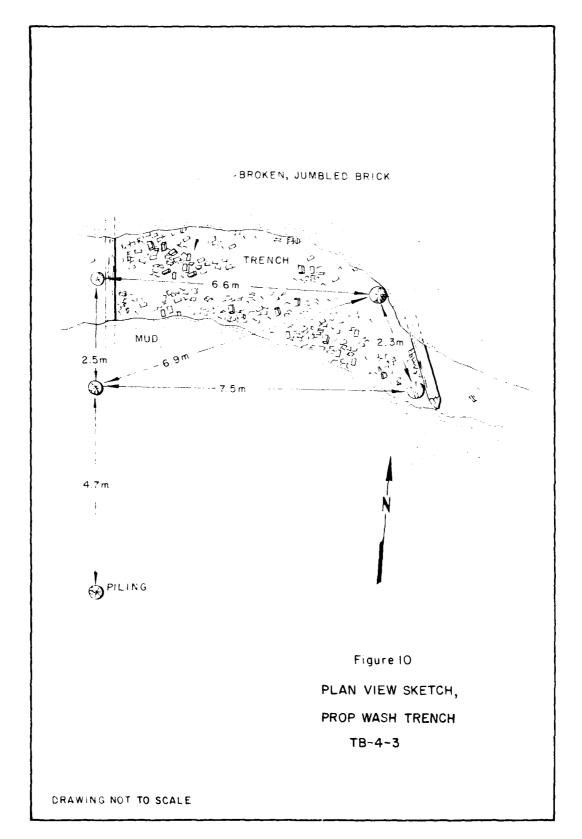
up to 8 ft (2.4 m). The brick mass was found to be contained between two rows of pilings (Fig. 10) oriented on its long axis from south-southeast to north-northwest. Five vertical pilings, 0.8 ft (0.24 m) in diameter and apparently hewn to a point at the upper end, are located in or adjacent to the excavated trench. The limited excavations indicated that the pilings ranged from 7.5 ft (2.3 m) to 15.4 ft (4.7 m) apart in each row and the two rows are 21.4 ft (6.5 m) to 24.7 ft (7.5 m) apart.

A heavy beam measuring 1.25 ft x 2.3 ft $(0.38 \times 0.7 \text{ m})$ abuts against the inside of the row of pilings on the west-southwest side and appears to be held in place only by the weight of the bricks piled against it. Another timber was found lying parallel to the east-northeast side but it is on the outside of the row of pilings. This timber, which was hewn to a point on the exposed end, measured 0.8 ft (0.24 m) in diameter.

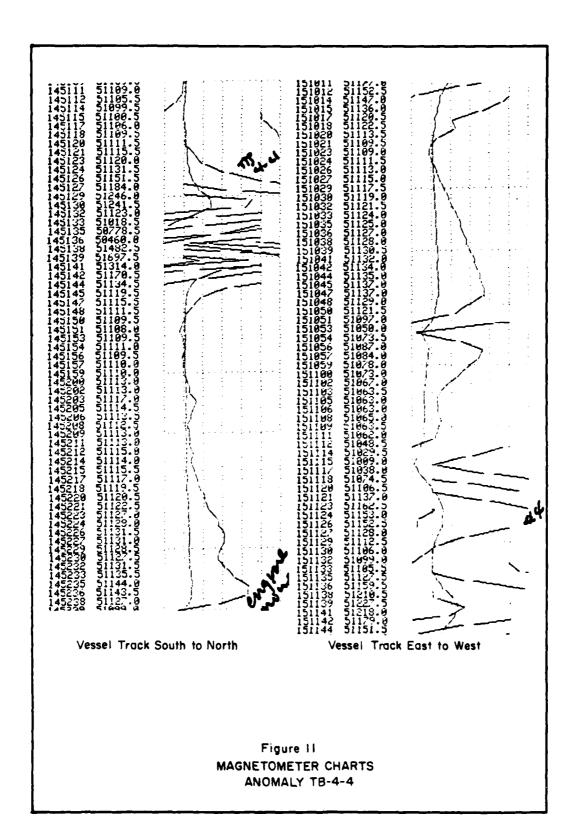
Anomaly TB-4-4 was located in 12 ft of water (3.6 m) on a sandy silt bottom. Its magnetic signature was found to be strong (780 gammas) and bipolar but of short duration on a north-south track. On an east-west track, the greatest magnetic deviation was only 117 gammas, but the signature was expressed in complex multiple peaks over a considerably longer distance (Fig. 11).

A buoy was placed at the point of greatest magnetic deviation. Divers were sent over the side to conduct a tethered circle search and reported within minutes that the buoy anchor had fallen amidst tangled coils of heavy gauge steel cable. The cable measured 1.25 inch (3.2 cm) in diameter and approximately 200 ft (61 m) in length. The coils looped tightly along an eastwest line, which accounted for the longer signal duration in that track. Strands of yellow polypropylene rope were also wrapped around part of the cable. The bulk of the cable proved to cause too much drag for total removal with the vessel at hand. However, the removal of portions of the cable resulted in a significant reduction of the signal. The cable is composed of six strands with 12 wires to the strand and seven hemp centers. It is of a type generally employed as mooring lines (American Cable Company 1932:26).

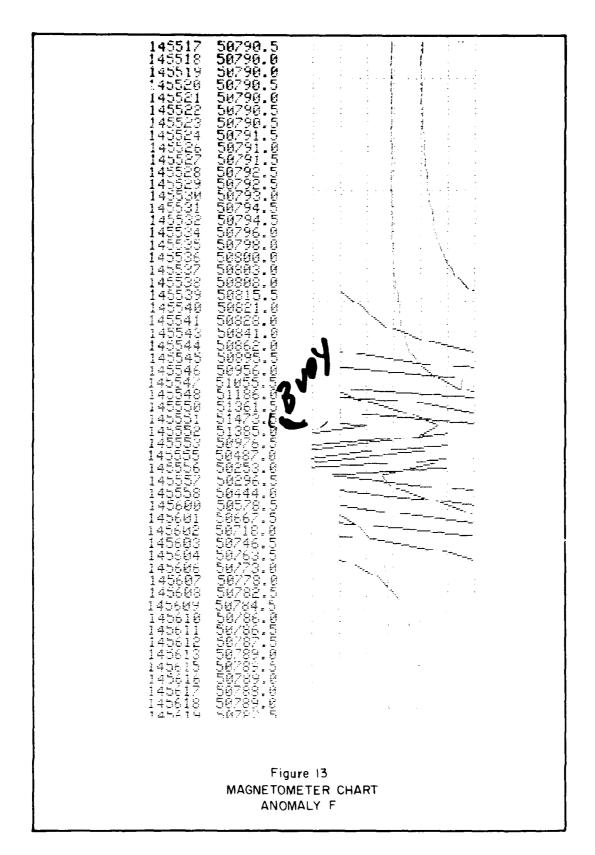
F

Anomaly F, producing a magnetic reading of 683 gammas (Fig. 13), was the strongest anomaly in the Transshipment Facility and the first to be tested in the Lower Bay. The anomaly was located on a sandy bottom in 24 ft (7.3 m) of water. Visibility varied from 15 ft (4.6 m) to 3 ft (0.9 m), depending upon wind and tide. The current in this area could, at maximum ebb, reach a velocity of 3-kt.

After isolating the point of greatest magnetic deviation and marking it with a buoy, divers were sent over the side to conduct a visual search within a 45 ft (13.7 m) radius of the buoy. The anomaly was quickly found to be generated by a jumble of steel wreckage in the form of pipes, I-beams, rods and cable protruding from the sand bottom (Fig. 14). Numerous fishing weights and hooks, shrimp nets and a short-handled spade were tangled up in the wreckage.
